Confidential Inspection Report

5380 Roberts Ave
Lewiston, NY 14092

May 12, 2017

Prepared for: Weston Solutions, Inc

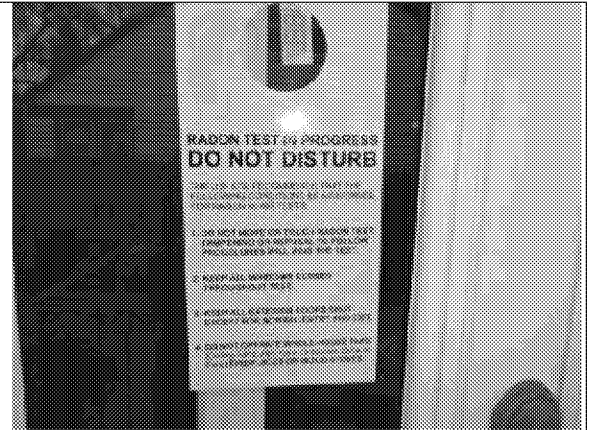
Radon Test In Progress Sign Posted:

Yes, a radon test in progress sign was posted in a conspicuous area of the structure. This notice also contained a listing of the testing conditions.

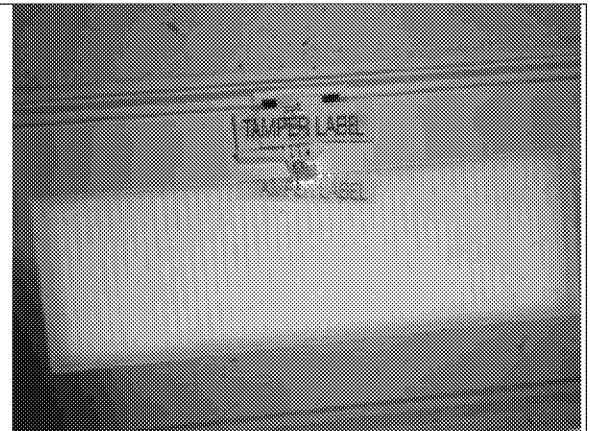
Windows & Non-essential Doors Sealed:

The windows and non-essential doors were sealed or tagged.

None of the installed seals were disturbed.
